The Re

of the Olympic stadium

n of Helsinki 1991-94

Obnova helsinškog Olimpijskog stadiona 1991-94.

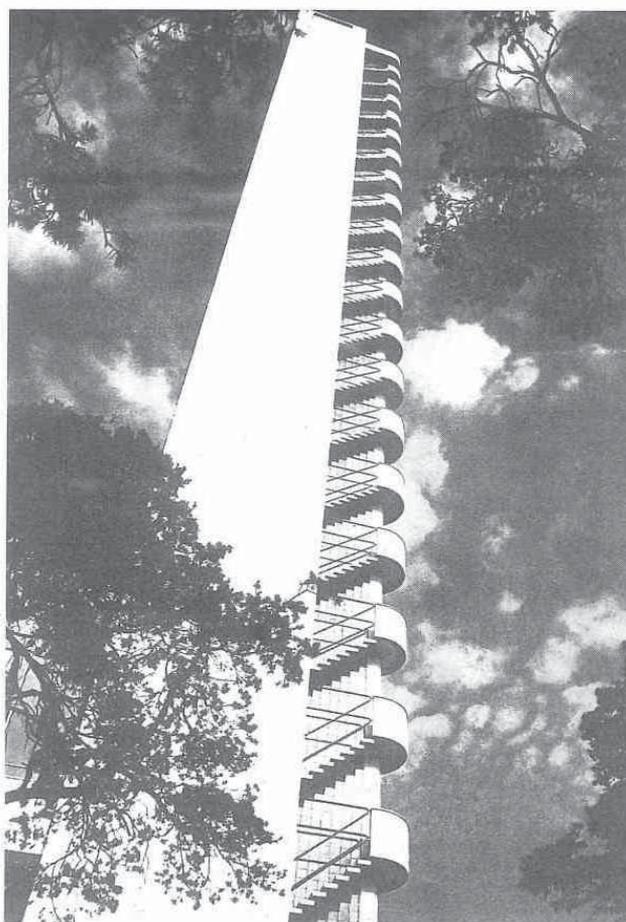
1 The tower of the Stadium is a landmark seen from all over the City of Helsinki. Foto Roos 1938 / *Toranj stadiona je značajan orijentir u slici grada Helsinkija, foto: Roos, 1938.*

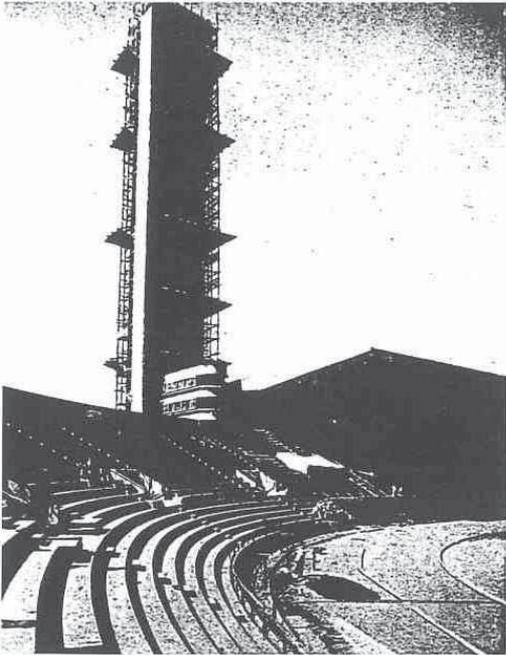
2

Tornin rakennustelineet

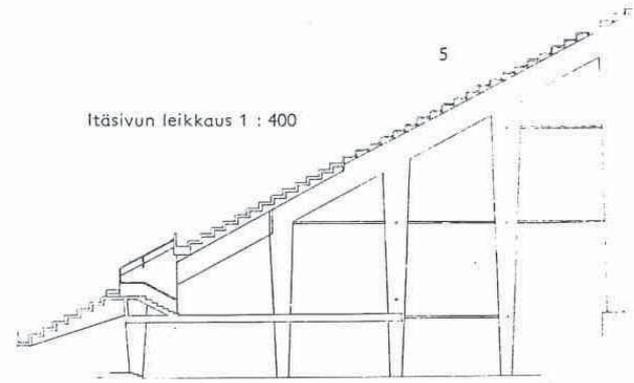
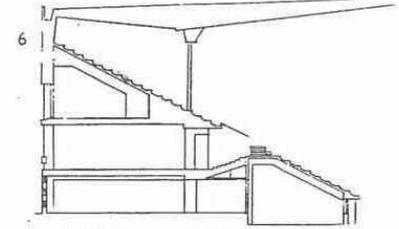
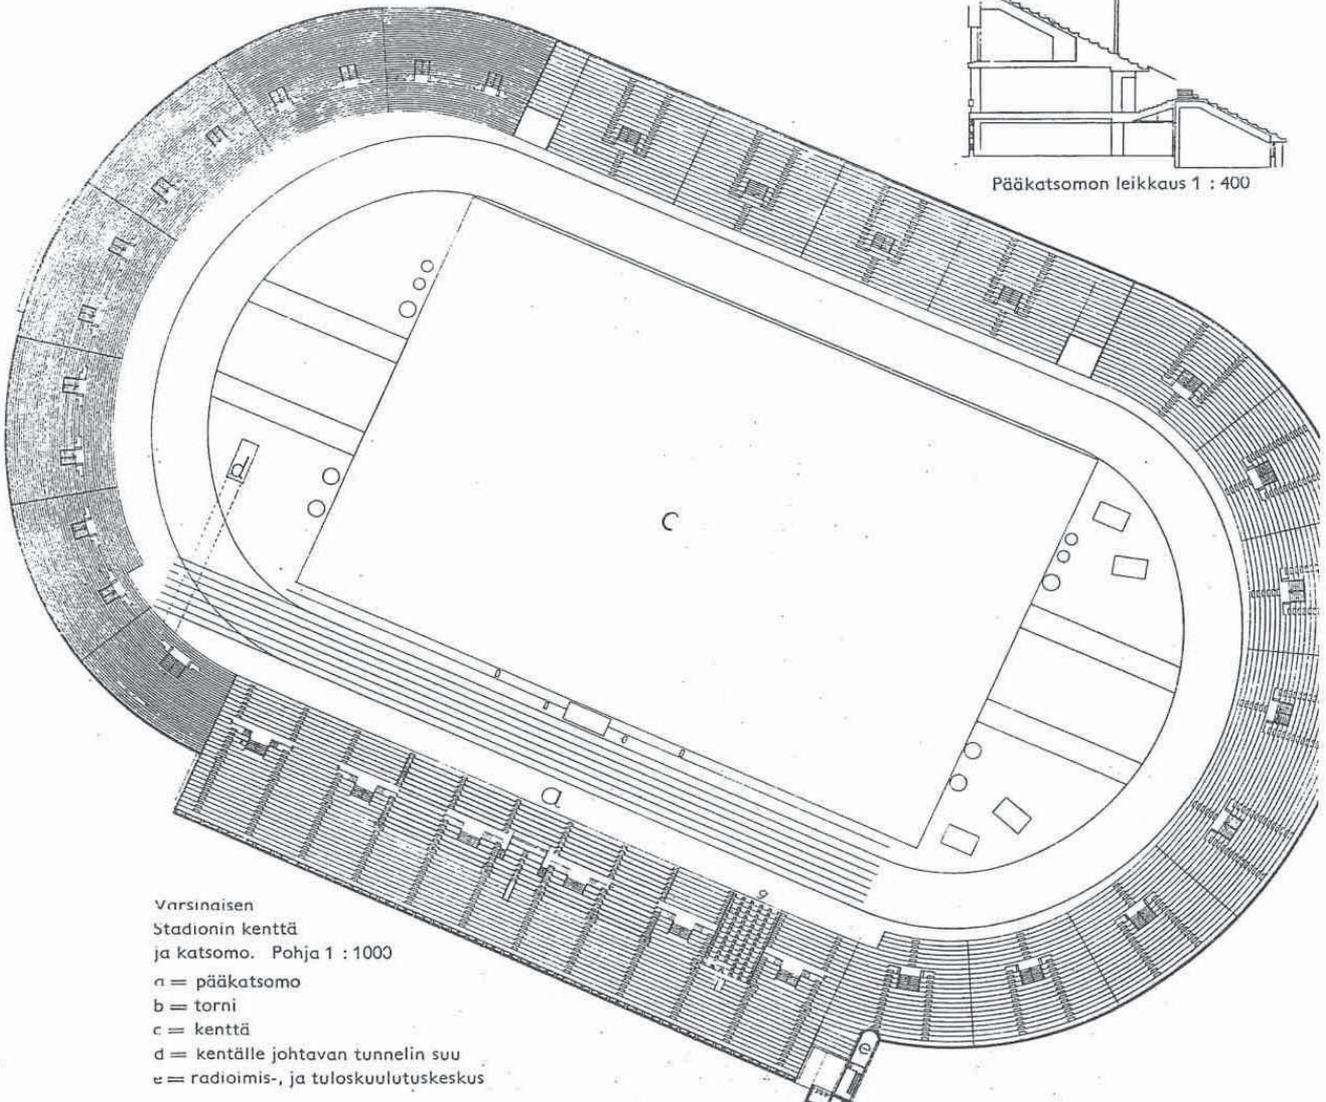
HELSINGIN STADION

Kaarteen leikkaus 1 : 400

Itäisivun leikkaus 1 : 400

Pääkatsomon leikkaus 1 : 400

Varsinaisen
Stadionin kenttä
ja katsomo. Pohja 1 : 1000
a = pääkatsomo
b = torni
c = kenttä
d = kentälle johtavan tunnelin suu
e = radioimis-, ja tuloskuulutuskkeskus

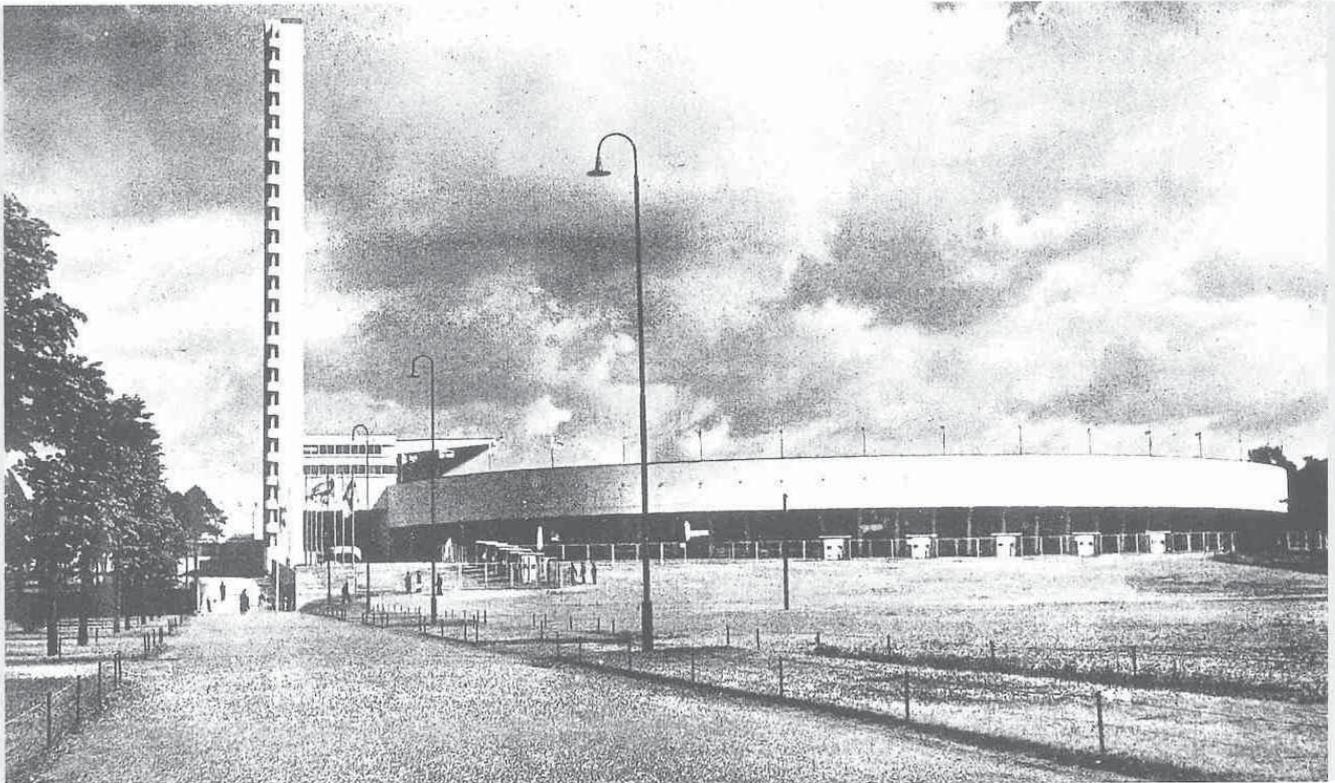
3 The Stadium in 1938 seen from the south. Foto Roos / *Stadion snimljen s juga, foto: Roos, 1938.*

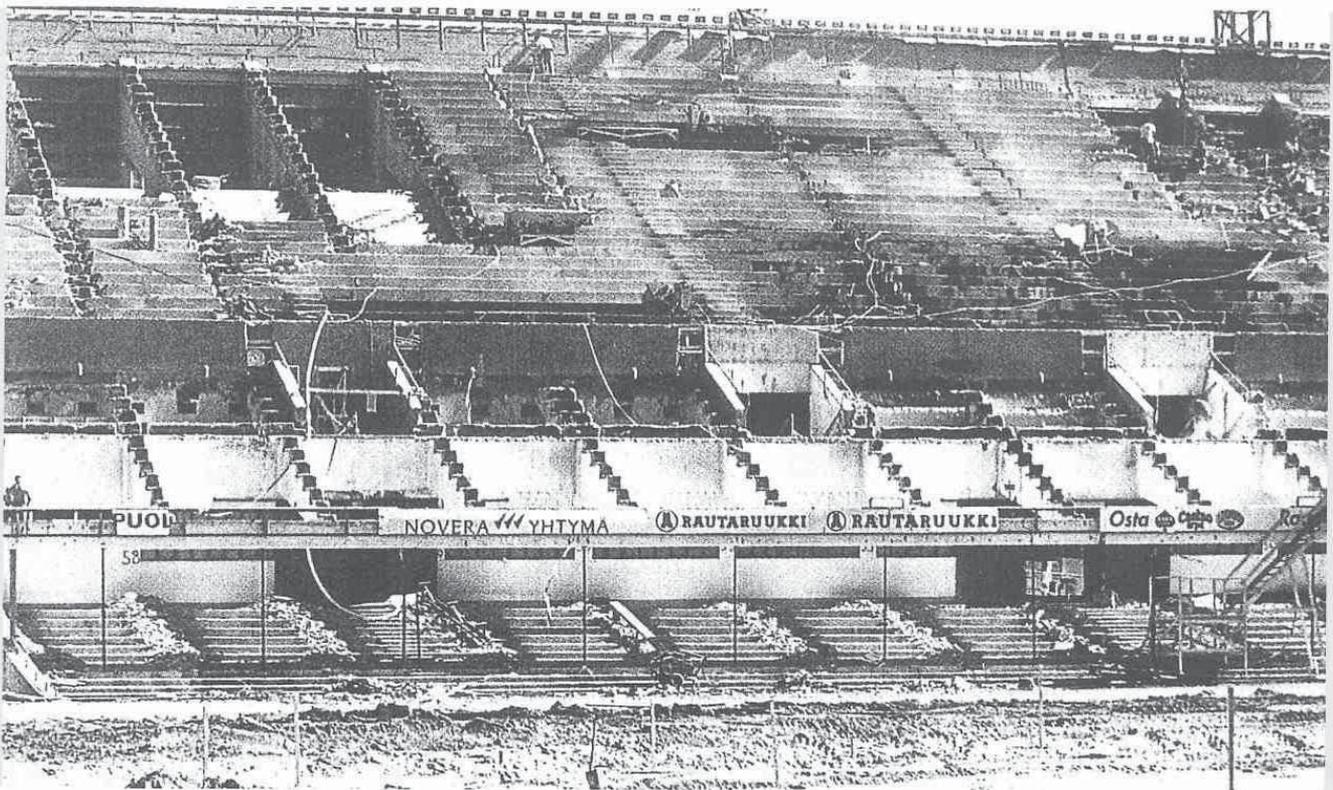
4 The stages during the refurbishment 1992 / *Tribine u jednoj fazi obnove, 1992.*

At the same time, the crude repair of the deteriorated concrete parts continued. There were alternative ways to repair the concrete seating stages: - it would have been possible to remove the completely deteriorated horizontal planes and cast new parts on site, i.e. to use similar method than was used in 1930's³, - or to install

prefabricated elements on the supporting pillars. The latter method needed additional new beams to bind together the bearing pillar system. Unfortunately the latter method was chosen although it meant to changing the original continuous construction. The Stadium as a progressive modern construction lost a lot of its original avant-garde elegance. The former high jumper is now a disabled veteran standing with the air of crutches. The horizontal supporting constructions were treated by sandblasting the carbonized surfaces and the rust irons, and then rust-protecting the irons and casting a new concrete layer on top.

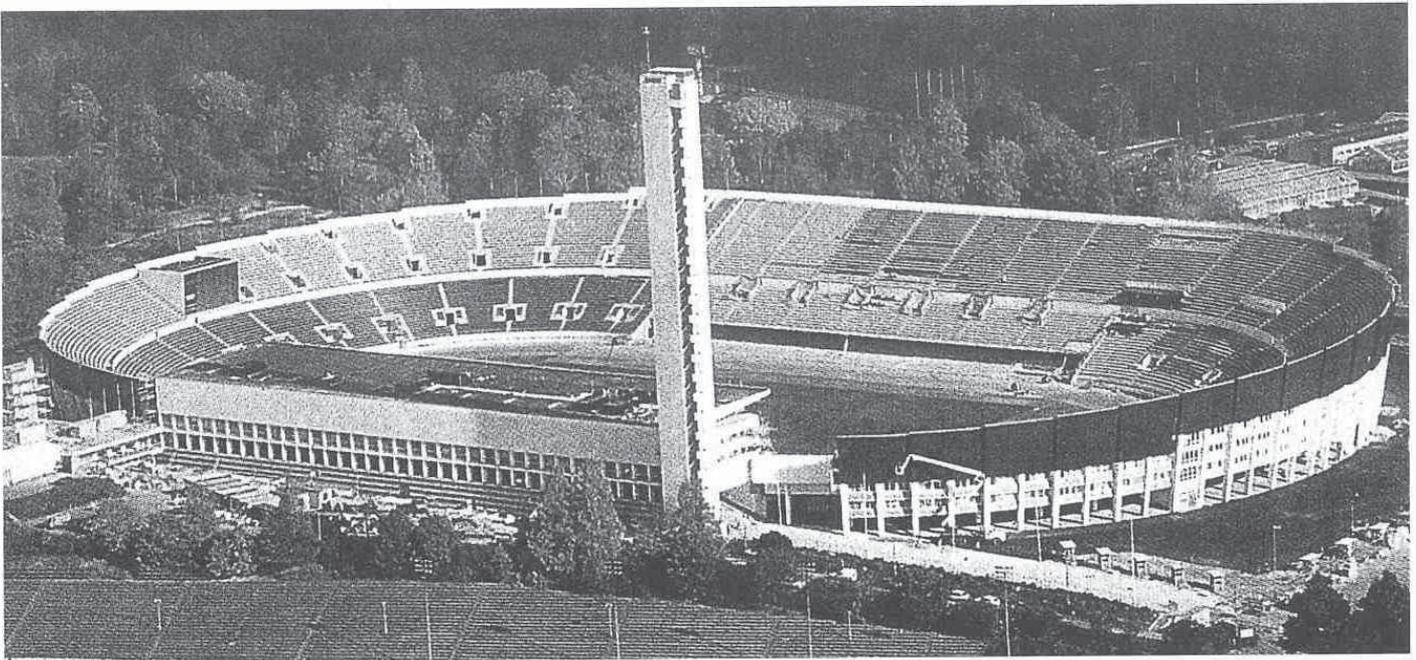
5 The present stage of the Stadium / *Sadašnji izgled stadiona*
